Imagery Analysis Report

Failure of San-men Gorge Reservoir Project, China

FAILURE OF SAN-MEN GORGE RESERVOIR PROJECT, CHINA

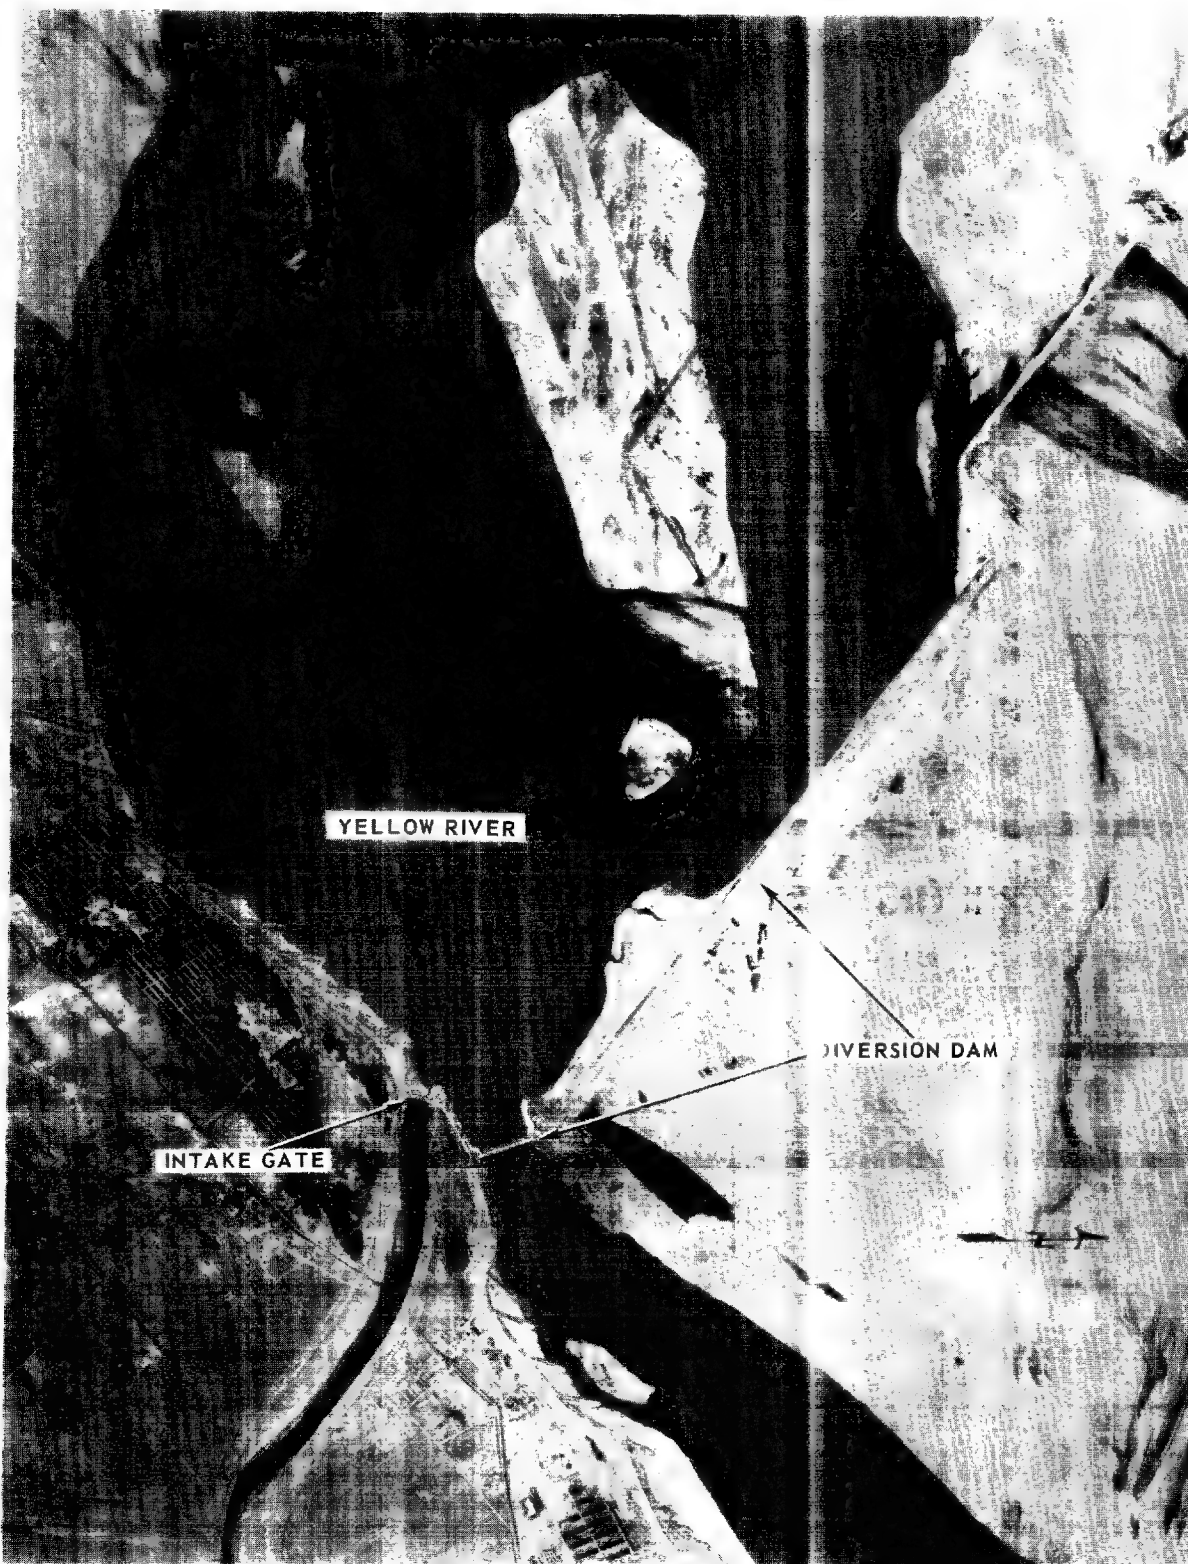
FIGURE 6. CHENG-CHOU CANAL INTAKE GATE. [REDACTED]

The deposition of sediment in a reservoir and the subsequent release of clear water will generally cause a scour or degradation of river bed below the dam. The removal of bed deposits by clear water may lower the river below existing canal intake structures.

Photography [] indicated the Chinese are having difficulty in obtaining a sufficient supply of water for the Cheng-chou and Lan-feng Irrigation Projects (Figures 6 and 8) located 130 and 210 nautical miles downstream from the dam. During this five year period the canal intake gates were photographed in both the wet and dry seasons, times when the river would normally be at its highest and lowest levels. Dates when the water was above or below the intake gates are given in Table 2. This table includes all available coverage from the date the dam was closed until []. Since there is insufficient photographic coverage of the canal intake gates before the dam was closed, the extent of retrogression cannot be determined. It is evident, however, that only a small amount of water for irrigation is available during the wet season and that even less water is available during the winter wheat growing season of March, April, and May when evaporation generally exceeds rainfall in these irrigation projects. In addition, during the wet season of 1955, flood waters destroyed the major portion of the Cheng-chou Diversionary Dam located at 34-55N 113-36E (Figures 6 and 7). This further complicates the task of obtaining sufficient water for the Cheng-chou Irrigation project.
